# Ups and downs of stairway cases

*Stairways are a major contributor to trip-and-fall cases, often producing life-changing injuries*

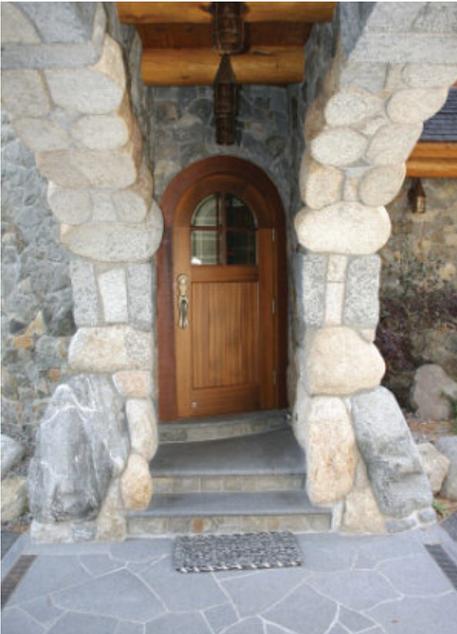
The stairway of the guesthouse at a Tahoe estate.

The stairway in this case was located at a Tahoe compound outside the “Guest Wing/Dormitory” building. The stairway was located under a rough-hewn stone covered bridge that leads from the main house to a round turret structure that houses an internal circular stairway up to the guest dormitory. All in all a rather innocuous-looking, Hansel and Gretel fairy tale feel. But the beauty of the

The stairway consists of three steps total, none of which is uniform with any other. The first step is rectangular in shape, with boulders encroaching the tread for several inches on either side; the second step is unusual in that it meets neither the CBC requirements for a landing nor for a step, and its shape is best described as an irregular rectangle with a concave curve at the far side; and the third step is a curved step to the threshold of a round top door. Neither the door nor the third step are parallel to the nosing of the first two steps (or step/landing) but rather are canted at a 22.5 degree angle away from the plane of the steps.

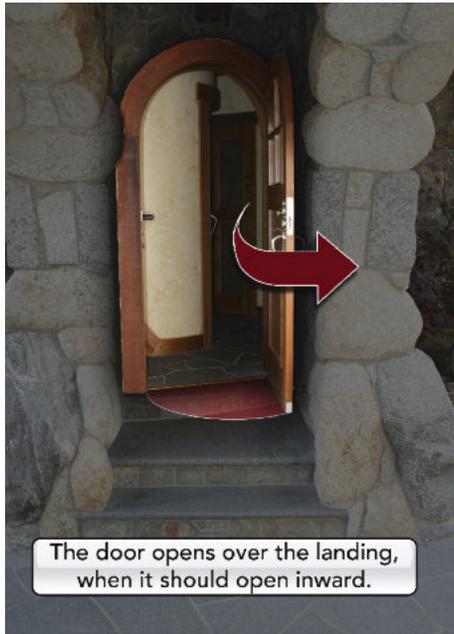
Violation 1

**•Violation #1: door swings out over landing**

The 2001 California Building Code, section 1003.3.1.6 provides: “Floor level at doors. Regardless of the occupant load served, there shall be a floor or landing on each side of a door.” Under Exception 1.2, the section provides: “A door may open at a landing that is not more than 8 inches lower than the floor level, provided the door does not swing over the landing.” (2001 CBC Section 1003.3.1.6.) The purpose of this code section is to avoid any surprises to a person passing through the door opening. Therefore, it is necessary that there be a floor or landing on each side of doorway. It is permissible to have a step at the doorway, but for safety purposes the door must not swing out over the landing. Here, the door swing forces a user outside the door backwards onto a landing that is not dimensionally safe.

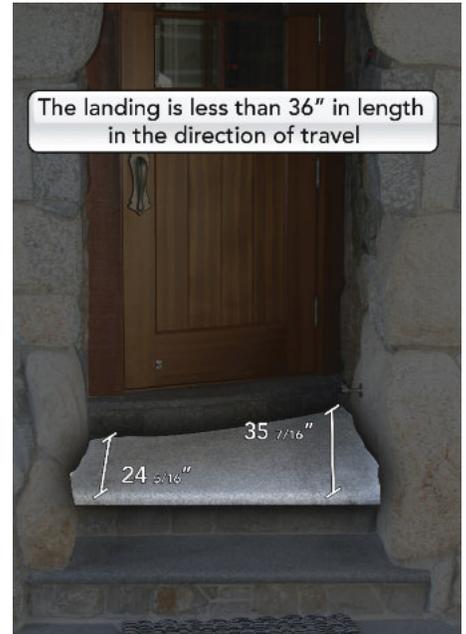
Violation 2

**•Violation #2: landing dimension**

Here, the irregularly-shaped landing does not comport with the dimensional length requirements of the Code. The Code requires a consistent and uniform minimum 36 inches in length in the direction of travel for the entire landing space in front of the door. This landing varies in a concave arc from roughly 24” on the left side to 35” on the right. (See detail 5 on CAD drawings, attached hereto as Exhibit 1.) This dimensional irregularity is not what a user of the stairs would expect, thereby creating potential confusion and disrupting one’s gait. Therefore, the landing is not code-compliant and further contributes to the unsafe condition of the stairs.

The rise of the first step measures 7 and 9/16 inches at center, and ranges from 7 & 13/16 inches at the left to 7 and 5/16 inches at the right. (See photos labeled Violation 2, 3, 5 and 6 on pages 2-4).

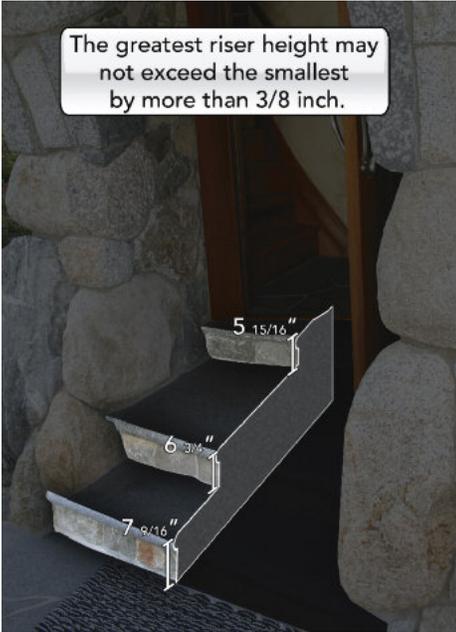
Violation 3

**•Violation #3: riser heights are not uniform**

Section 1003.3.3 provides: “Rise and run. The rise of steps and stairs shall not be less than 4 inches nor more than 7 inches. The greatest riser height within any flight of stairs shall not exceed the smallest by more than 3/8 inch.” (2001 CBC Section 1003.3.3.) Thus, the greatest variance in height between any two risers may not exceed 3/8 inch. Here, the risers all vary from each other by amounts well beyond what the Code allows:

The rise of the third step to the threshold measures 5 and 15/16”. Thus, the stairway violates the Code because the comparative riser height of all of the steps varies far beyond the 3/8” maximum allowed: (1) the first step is nearly 1 inch higher than the second step, which is 2.5 times greater than the maximum allowed; (2) the first step is 2.5 inches greater than the third step, which is nearly 7 times greater than the maximum allowed; (3) the height of the second step is 1 and 7/16” higher than the third step, which is approximately four times greater than the maximum amount allowed by the code.

These variances in riser heights – not by fractions of inches but rather by a factor of multiples of the Code maximum allowance, cause a user to encounter an unexpectedly asymmetrical stairway which throws off the user’s gait. This code violation further contributes to the unsafe condition of the stairs.

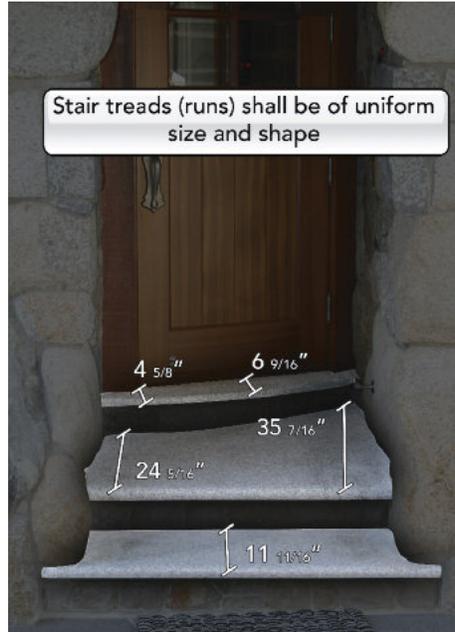
Violation 4

#### •Violation #4: tread depth

Section 1003.3.3.3 provides: “Rise and run. . . . Stair treads shall be of uniform size and shape, except the largest tread run within any flight of stairs shall not exceed the smallest by more than 3/8 inch.”

Here, defendants may take the position that the second step is not a landing because it fails to meet the Code requirements for a landing. If defendants take such a position, the second step still violates this section because it is not uniform dimensionally – its concave shape is not uniform and also differs significantly from the other steps. This code violation also creates a condition not expected by users of the stairs, which they are likely to become confused by, and further contributes to the unsafe condition of the stairs.

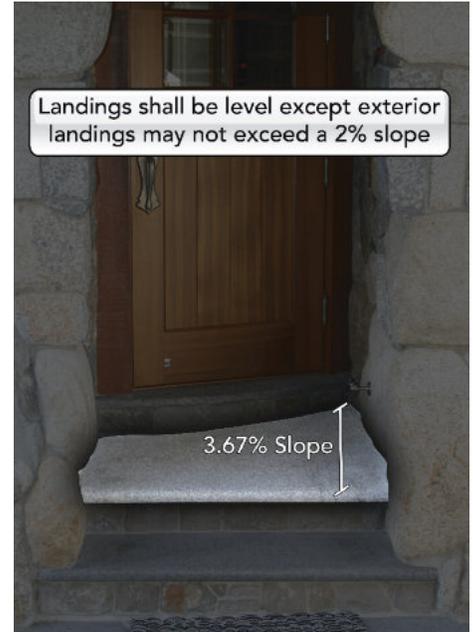
Violation 5

#### •Violation #5: landing slope

Here, the stairway landing violates the code because the landing’s slope is 3.67 percent, which is 83 percent greater than the code maximum 2 percent. As with the other violations, this code violation also creates a condition that users of the stairs do not expect, are likely to become confused by, and throws off one’s gait.

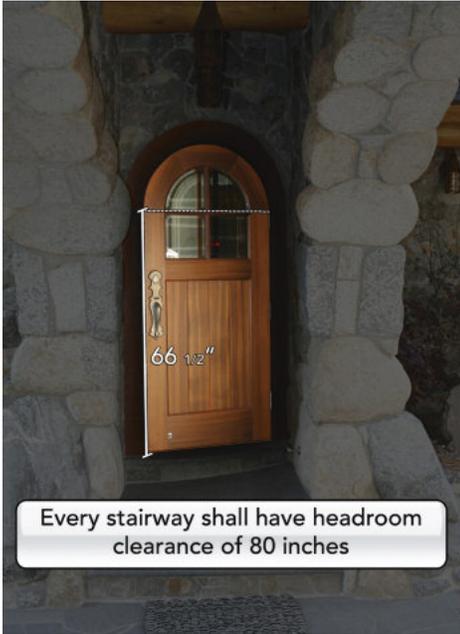
Violation 6

#### •Violation #6: headroom clearance

Section 1003.3.3.4 provides: “Headroom. Every stairway shall have a headroom clearance of not less than 6 feet 8 inches. Such clearance shall be measured vertically from a plane parallel and tangent to the stairway tread nosing to the soffit or other construction above at all points.”

Because a step runs continuously along the stairway door, the 6-foot-8-inch headroom requirement applies at all points along the tread nosing at the threshold. The stairway does not meet the headroom requirement, because clearance at points where the rounded door begins its tangent (i.e. from an upward plane beginning at the right and leftmost points on the tread nosing) is only 66 and 1/2”, more than 14” lower than the Code minimum.

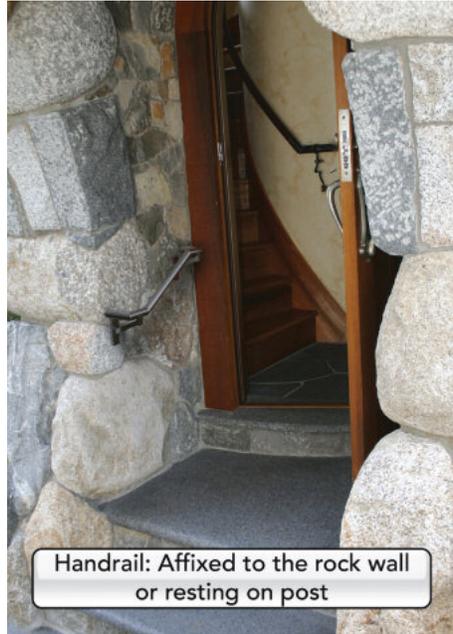
Plaintiff expert created this digitally enhanced photo to show how a handrail could have been added to increase safety.

the accident?” A handrail violation is the most common building code violation that is intuitively linked to causation. But what of the violations above? Notably, there was no strict code requirement at that stairway, because it only had three risers. This is where it is important to consult with a safety expert or architect. The stairway is a system, and once safety of the system is compromised by the multiple building code violations at the stairs, defendants may not rely on the absence of a strict code requirement for a handrail to avoid liability. Here, given the stairway’s condition – with its uneven and asymmetrical steps – and the many safety laws it violated, numerous safety experts agreed that the “de minimus” cost of a handrail was minimally necessary to protect guests to the property. We used the trial graphic vendor to superimpose a handrail at the property here, to demonstrate that the cheap fix would have also fit in with the overall aesthetic of the property.
